## Analysis of slope stability hazards along hilly highways: Ain Sukhna-Zafarana highway, North Galala Plateau, Eastern Desert, Egypt

W. A. M. Ogila<sup>1</sup>, S. Abdeltawab<sup>1</sup>, A. M. Abdelkader<sup>1</sup>, M. Yousef<sup>1</sup>

<sup>1</sup>Geology Department, Faculty of Science, Ain Shams University, Cairo, Egypt.

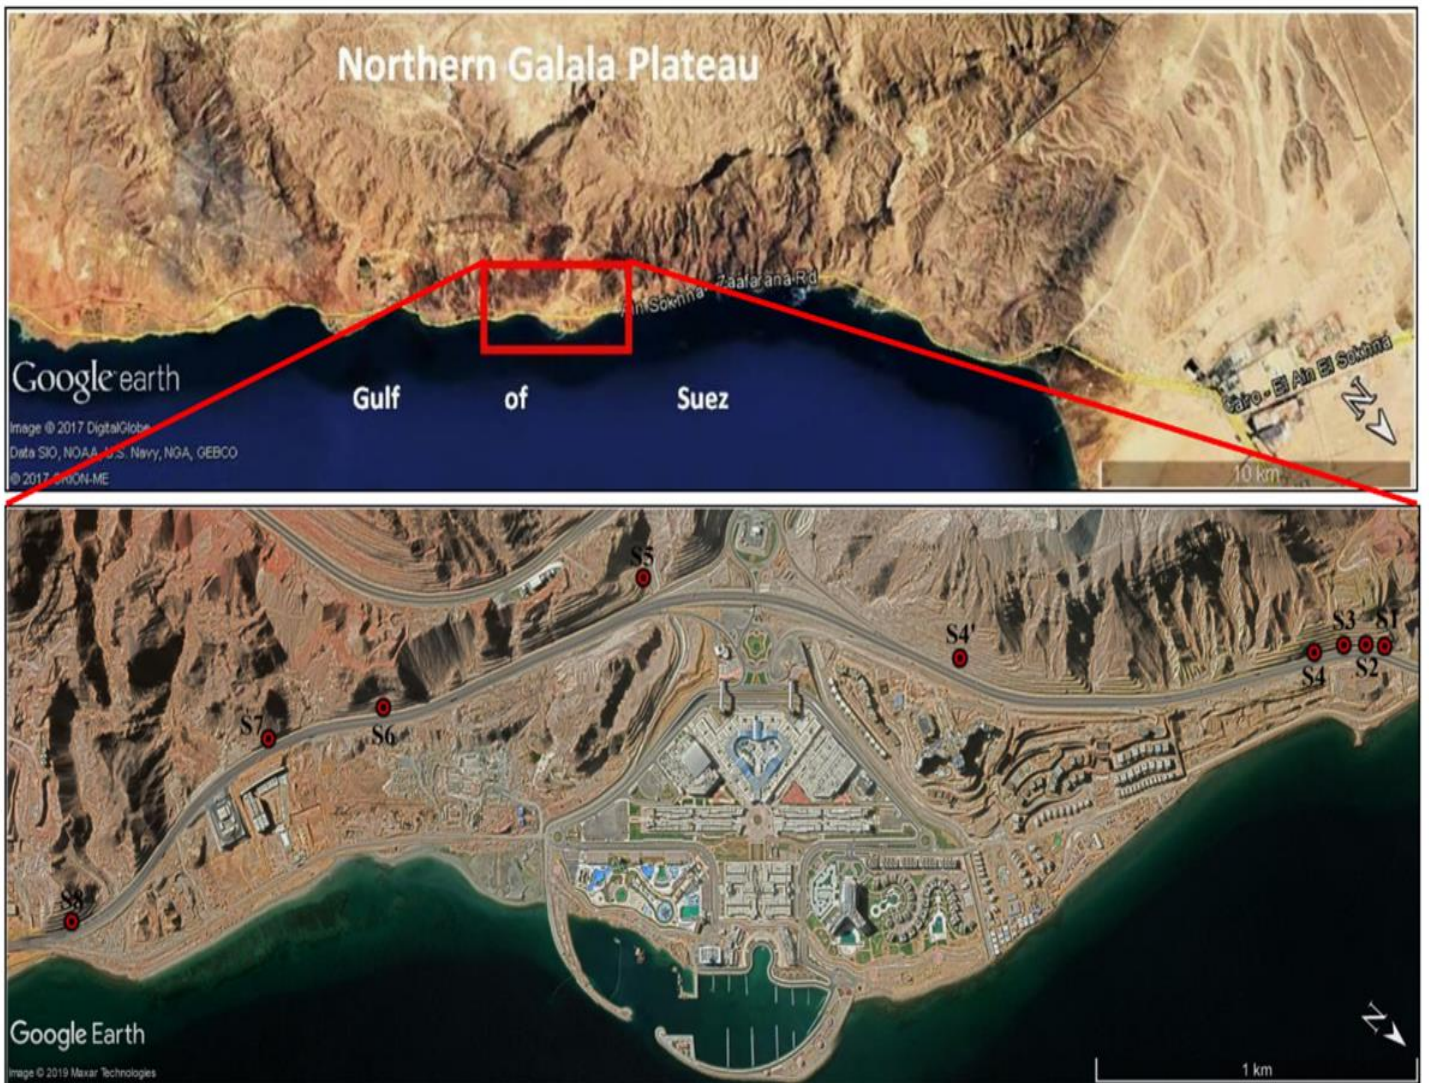
**Fig. 4** Google™ image showing the nine locations of discontinuity survey stations along Ain Sukhna-Zafarana highway

A detailed discontinuity survey was carried out on nine rock cuts along Ain Sukhna-Zafarana highway at Wadi Abu Darag area, Figs. 4 and 5. The dominant discontinuities, that affect the rock masses through the coastal strip and their surrounding resorts area are faults, joints, and bedding planes. The attitudes (dip amount and dip direction) of these structural elements are measured using the scanline technique following the right-hand rule. A total of 1638 joint planes were measured at nine locations along the excavated slopes, Fig. 4. These joint sets affect essentially the excavated slopes made up of Paleozoic interbedded sandstone and claystone, and black shale in the lower part as well as

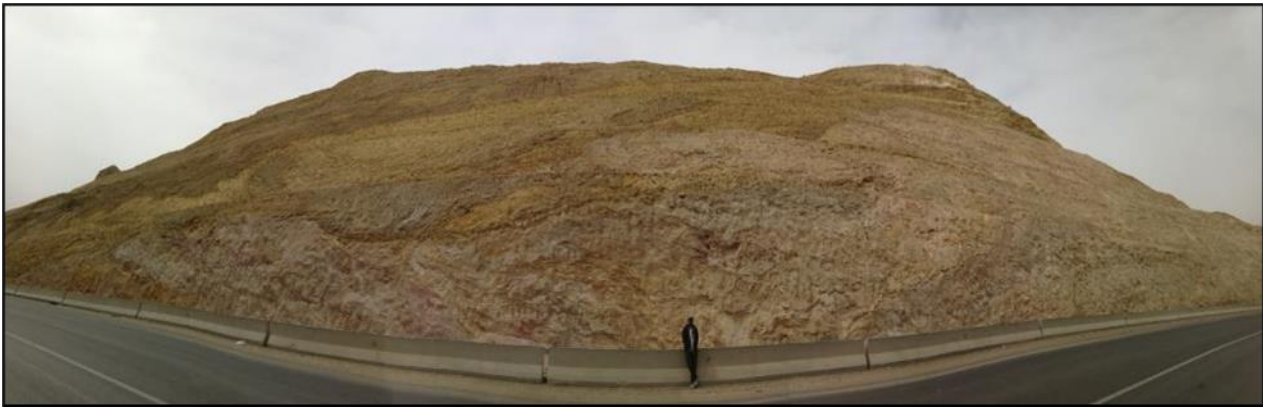
**Fig. 5** Field panoramic view of the existing rock cut slope in different rock masses along station no. (4)

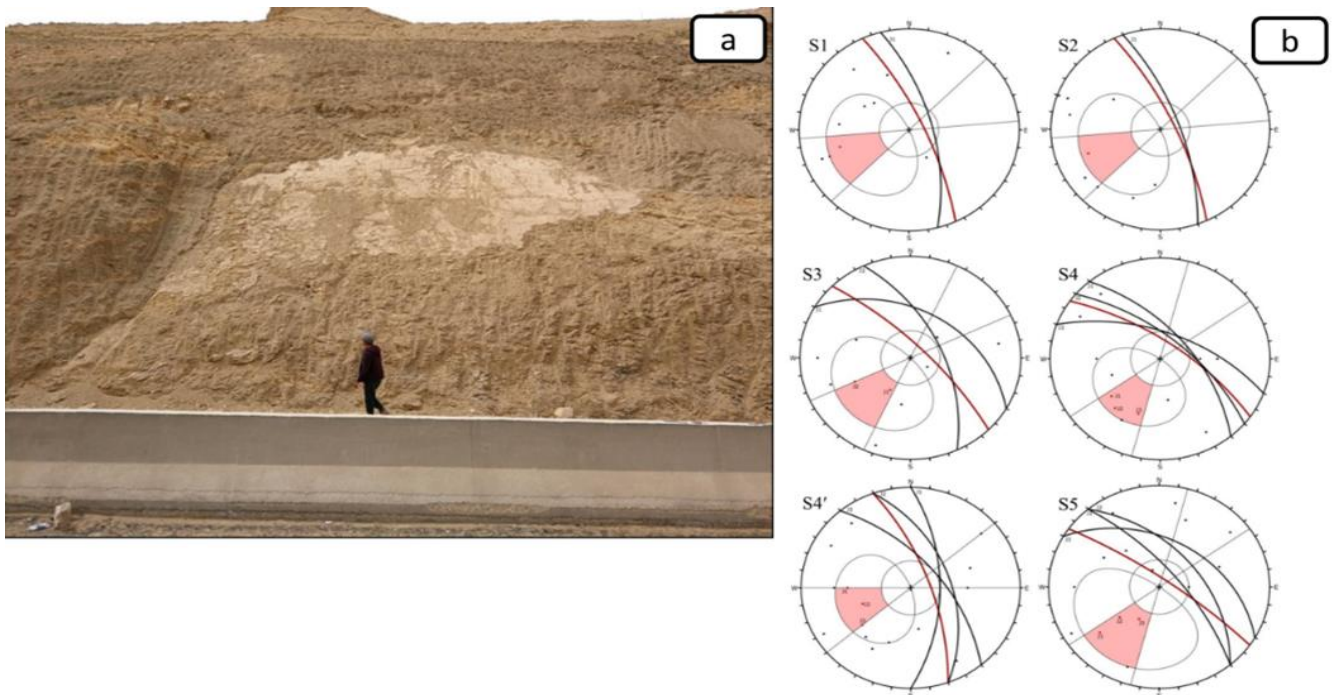
**Fig. 6** Field photograph (a) showing the planar failure along the existing rock cut slope controlled by major fault ( $F_1$ ) at station no. (4). Kinematic analysis (b) of the planar failure at the studied stations. The bold red arc is slope data (dip amount and dip direction), bold black arc is unfavorable discontinuities, black point is the discontinuities pole projection, red point is critical discontinuities pole projection, the gray circle represents friction angle of discontinuities and red area represents the critical zone for planar failure.

A planar failure can possibly occur if a discontinuity trend is parallel or sub-parallel (within  $\pm 20^\circ$ ) to the cut slope strike, with an angle less than that of the slope angle, and greater than that of the friction angle of the failure plane [13]. In this study, the planar failure can be expected to occur frequently in the existing rock cut slopes where the conditions of planar failure are fulfilled in the moderately to highly fractured rock units, Fig. 6a. At some places, planar failure has already occurred after the slope excavation, because the cut slope is controlled by a major fault ( $F_1$ ) of a parallel strike to the excavated slope face, Fig. 6a. Planar failure is expected to occur in all stations except

station no. 8. The stereonet plot shows that the most unfavorable conditions for planar failure are controlled by discontinuities  $J_1$ ,  $J_2$ ,  $J_3$  and  $J_4$ , Fig. 6b.

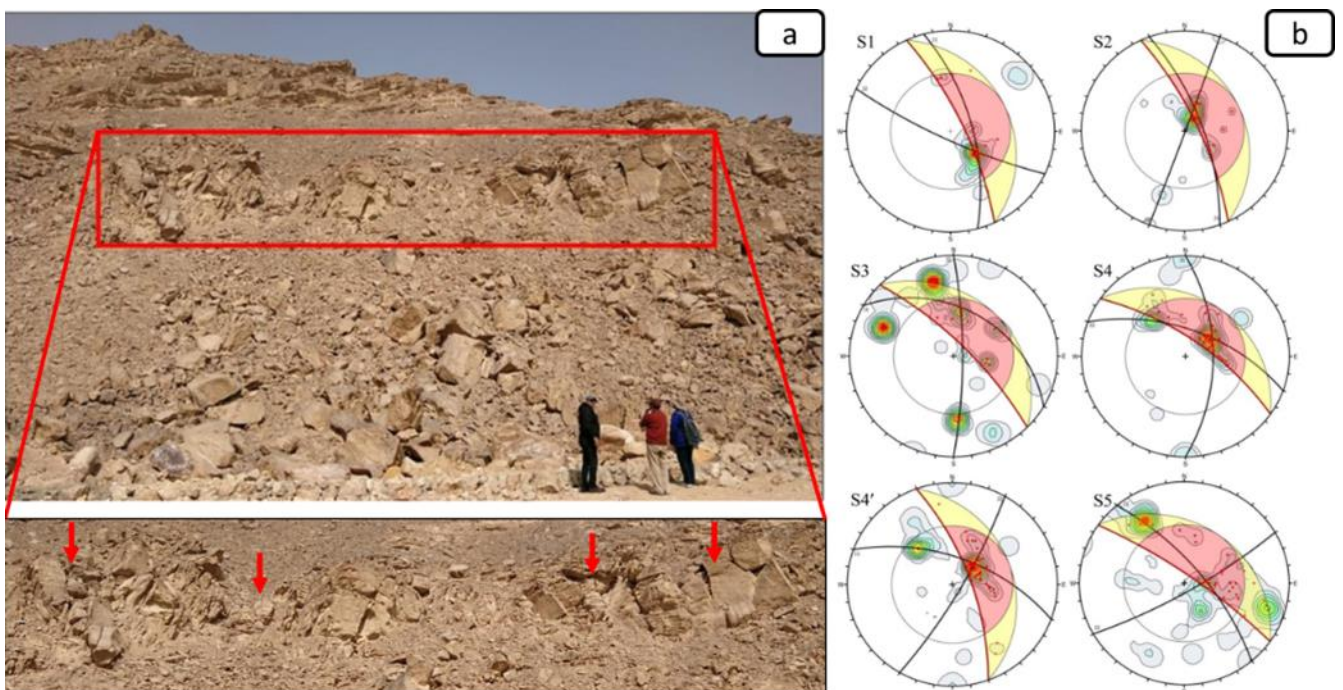
**Fig. 7** Field photograph (a) showing the small wedge failures in the upper part within the existing rock cut slope at station no. (4'), the red arrows indicate the locations of wedges. Kinematic analysis (b) of the wedge failure at the studied stations. The bold red arc is slope data, bold black arc is unfavorable discontinuities, black point is the measured discontinuities pole projection, red point is critical discontinuities pole projection, the gray circle represents friction angle of discontinuities and red area represents the critical zone for wedge failure

Wedge failure is expected to occur frequently in the rock cut slopes where the conditions of wedge failure are fulfilled in the highly fractured sandstone and shale series. At some places along Ain Sukhna-Zafarana highway, small wedge failures are observed in the existing rock cut slopes controlled by two intersecting fractures, Fig. 7a. Wedge failure is also expected to occur in all stations along the studied highway with small size blocks. The stereonet plot reveals that the most unfavorable condition for wedge failure is controlled by intersection of discontinuities  $J_1$  and  $J_2$ , Fig. 7b.

Deterministic analysis for slope stability is classified under the Limit Equilibrium Methods (LEM) [27,28]. This method is typically used to determine the factor of safety (FS) for the expected slope failures [29]. The deterministic analysis was carried out using the RocPlane V. (2.029) and SWedge V. (4.080) softwares for planar and wedge failures, respectively. The present study revealed that the geometry of all planar failures within the existing cut slopes, represented by RocPlane, is usually controlled by one set of fractures, Fig. 9. On the other hand, all possibilities of critical wedges within different slope geometries were identified using SWedge, revealing that they are frequently controlled by two intersecting discontinuity sets, Fig. 10. It should be noted that due to the large number of identified wedge failures at the studied stations, it is difficult to represent all these possibilities. A power weight for critical wedge failures was selected based on contour lines zonation analyzed by SWedge program, Fig. 7b. The input parameters

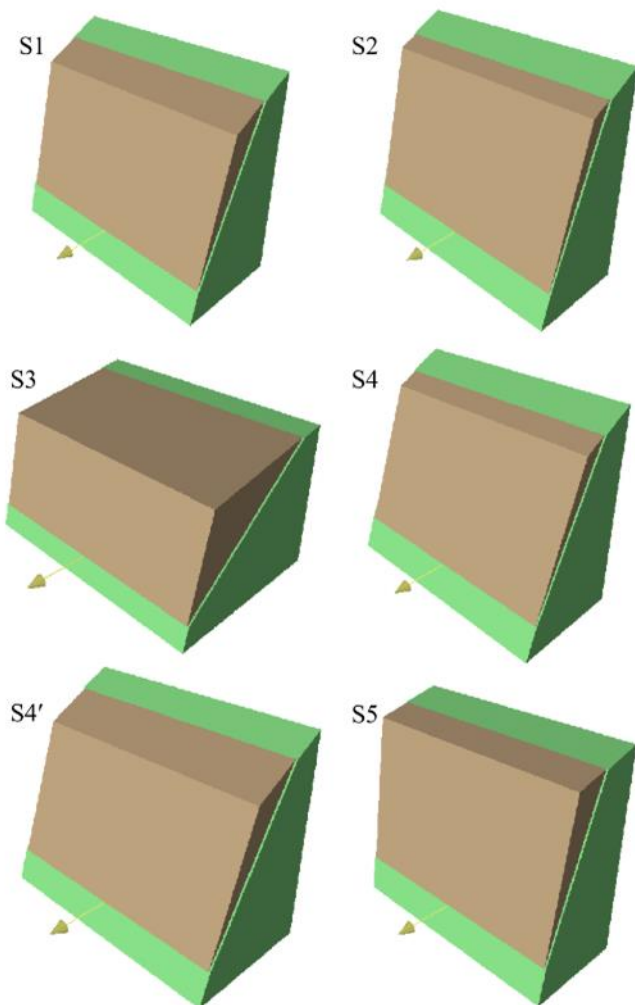
**Fig. 9** Three-dimensional (3D) deterministic analysis of the critical planar failure at the different studied stations

slopes have high values of safety factor in dry static and dynamic conditions. These values decrease dramatically with the presence of water (saturated conditions) in most cut rock slopes. The calculated FS of planar and wedge planes for the dry and saturated conditions are presented in Tables 3 and 4, respectively. The calculated FS in the case of dry cut slopes in static condition ranges from 0.93 to 1.89 for planar failure planes and from 1.25 to 2.48 for wedge failure planes. This means that the cut slopes are most probably stable in the static condition except one planar failure station no. (4) which is already slid down on site, Fig.6a. Based on the FS values of dry dynamic conditions, some unstable zones of

planar failures are observed at studied stations no. (1, 2, 4 and 5), whereas most of the wedge failures are in stable condition except the failures at the station no. (5 and 8). When the saturated condition is considered whether, in static or dynamic conditions for the cut slopes, the calculated FS is significantly reduced to be less than unity in most cases of both failure types as expected. This instability is mostly due to the reduction of shear strength and cohesion properties of rocks forming the slopes, which in turn lead to decreasing the friction angles. In this unfavorable condition, the failures are likely to occur during the high rainstorm events of the winter season which are considered as one of the external factors that helps to trigger these failures.

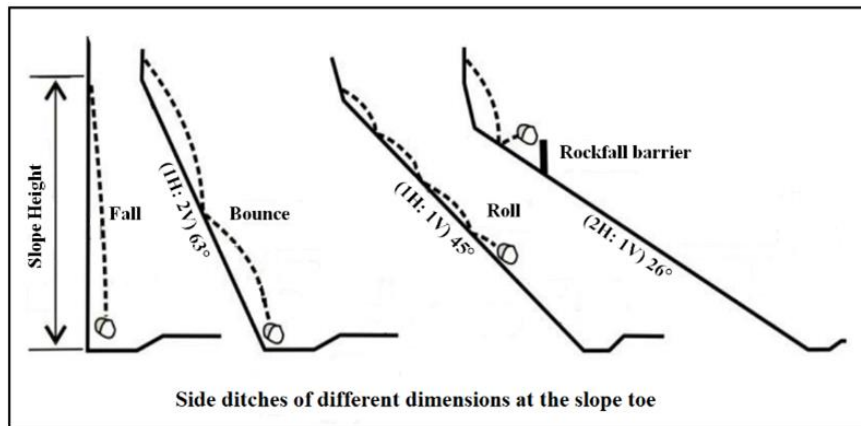
Fig. 11 The rockfall motion modes and suggested protection barrier (modified from<sup>[32]</sup>)

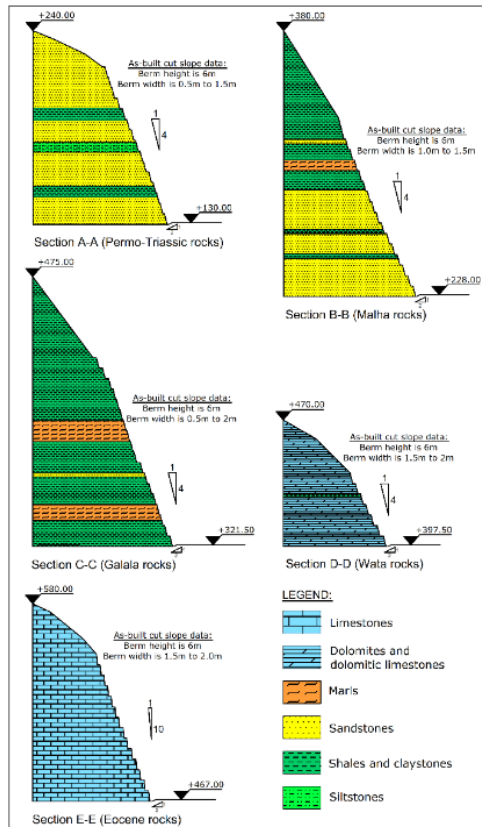
Fig. 13 Geologic cross-sections and geometry for the existing rock cuts along the studied road

retarding capacity of the slope surface influencing rockfall behavior. Two-dimensional (2D) rockfall simulation is executed along five selected profiles along the rock cut slopes to define the block trajectories, runout distance, kinetic energy and bounce height of the blocks. This investigation is based on the numerical analysis that was carried out by using computer software Rocscience™ RocFall v. 4.058, Fig. 14. The geological, geometrical, and engineering properties of both source and propagation areas are considered based on site conditions, Fig. 13.

energy and can cause more extensive damage than smaller ones. The roundness of these blocks is mostly angular with few subangular edged blocks. All blocks are derived from the slope body composed generally of limestone and sandstone, Fig.13.

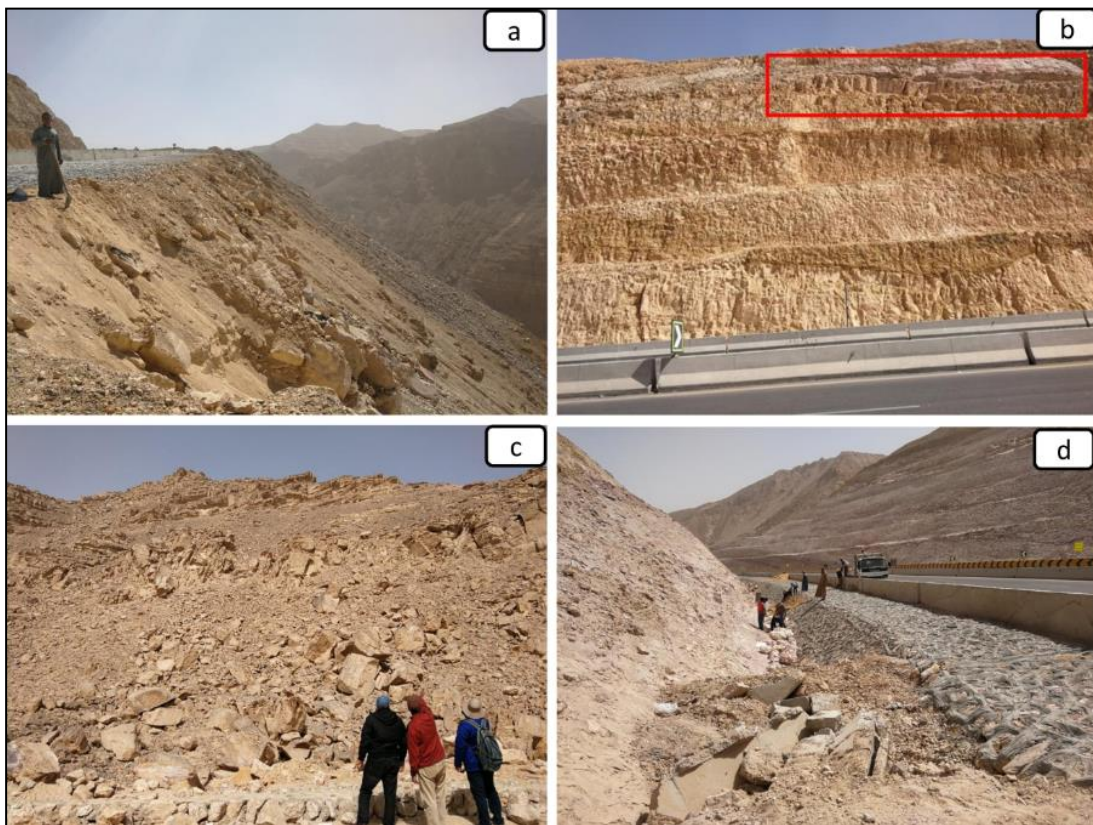
**Fig. 15** Site photographs showing (a) the rock fragments and dump materials at the upper part of slope (seed area), (b) the hanging rock blocks in the slope face (propagation area) at the upper part (the red rectangle), (c) The dominant block size which ranges between  $0.5 \text{ m}^3$  to  $3 \text{ m}^3$  and (d) the constructed side ditch at the slope toe with width of 2.5 m

The numerical simulation is carried out using the equations of rigid body motion to calculate velocity and bounce behavior of the rock fragments as it travels down at foot slope area. For the rockfall simulation, the seed area (source area of blocks) for the slope is selected particularly at the slope crest (back slope) and mid-slope areas along cut slope segments, Fig. 15a and 15b. Another significant source for block falling can be the highly fractured rocks on the slope faces. The propagation area (blocks path area) is selected along the cut slope profile under the seed area, Fig. 15b.

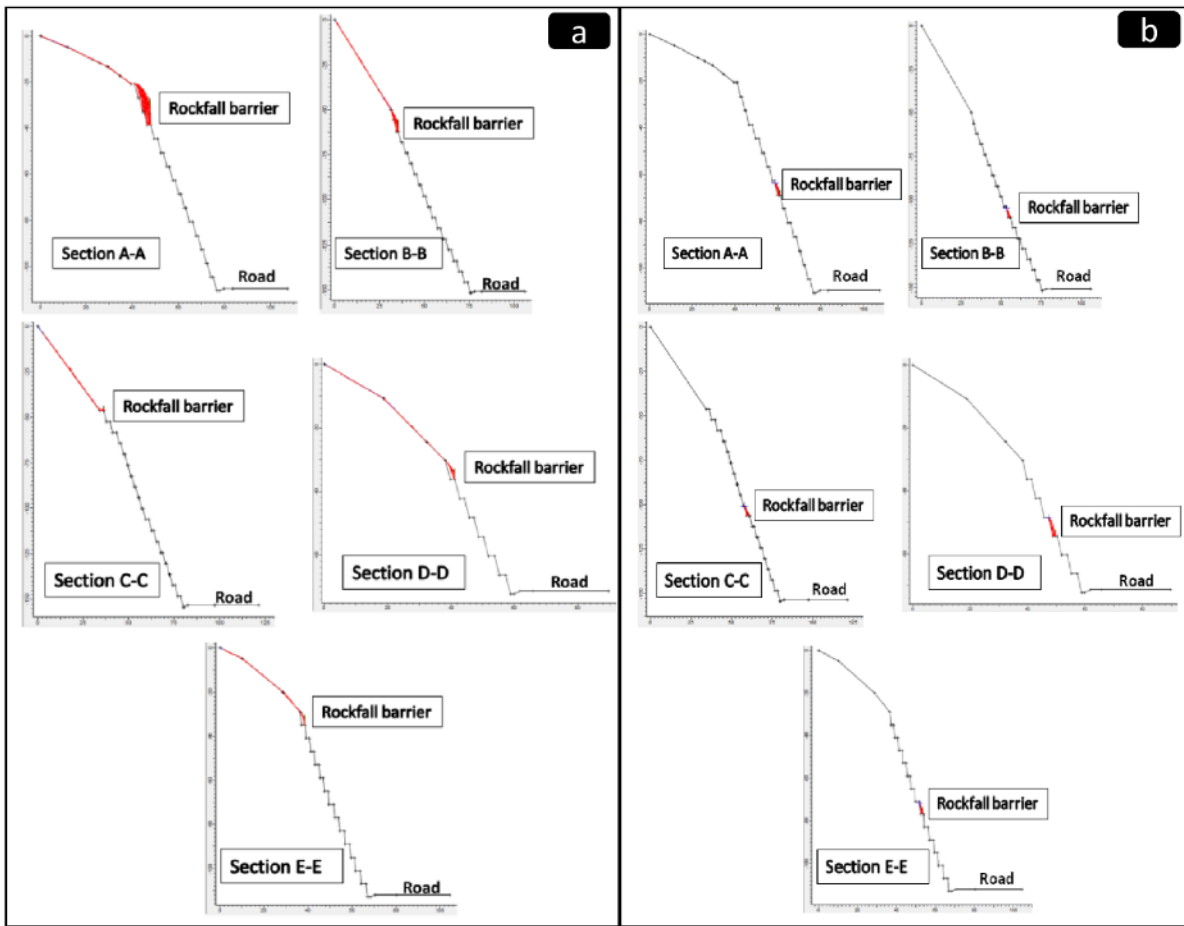
Fig. 16 Proposed locations for rockfall barriers or fences at (a) the upper part and (b) middle part of the studied cut slopes

The characteristics of rockfall trajectories (height and length of flight) allowed us to design and optimize positioning of protection works such as barriers and fences. Construction of rockfall barriers is a remedial measure for long runout distance and high bounce of falling blocks. In such cases, the protection barriers must be higher than the boulders trajectories that should be placed at most of the hazardous area.

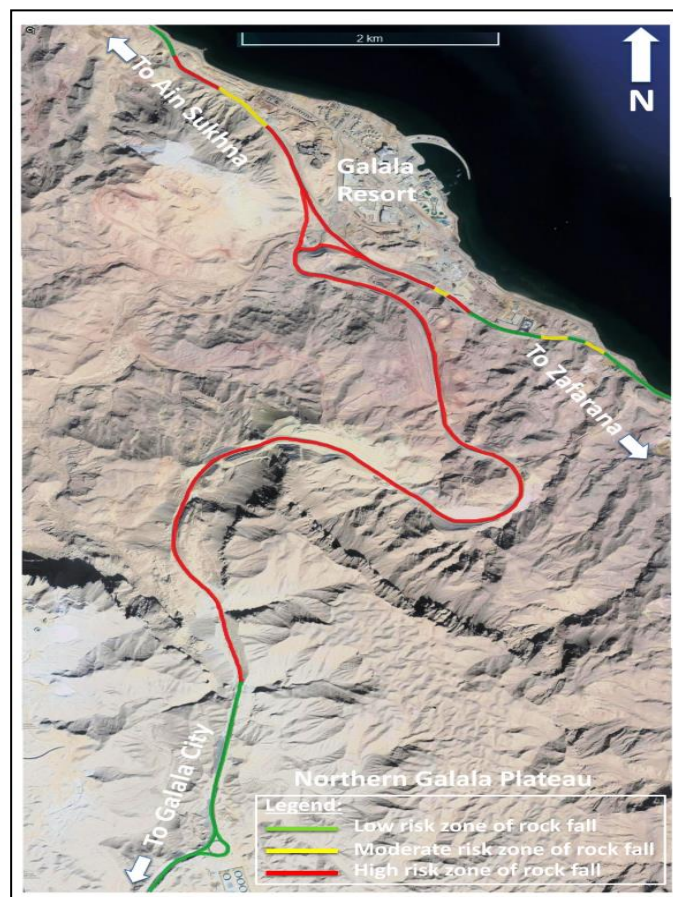
Fig. 17 The hazard zonation map of slope instability and rockfalls

Based on slope stability interpretation of the kinematic, deterministic and rockfall analyses, the studied road is clearly divided into several risk zones, Fig. 17. These proposed risk zones are divided according to the site inspection and encountered engineering geological conditions of different rock masses along the cut slopes. The studied road is divided into three categories low, moderate and high-risk zones of rockfall. On the map, low risk zones indicate low rockfalls potential to road (that is characterized by low rock cut height < 5m or no cut, low potential of rockfall or slope failures based on the site inspection, no slope failures observed along the cut slopes), moderate risk zones indicate moderate slope instability and rockfalls impact along the road (that is characterized by moderate rock cut height ranges from 5m to 12m, moderate potential of rockfall or slope failures based on the site inspection, moderately poor blasting excavation, moderate

intensity of hanging blocks on slope face and back slope area, slope failures or rockfalls observed along few cut slopes), and the highly dangerous segments of the road indicate the road subjected to intensive rockfall or rock sliding events (that is characterized by high rock cut height >12m, high potential of rockfall or slope failures with high kinetic energy (average 1705 KJ), poor blasting excavation, high intensity of hanging blocks on slope face and back slope area, low safety factor (average 0.86), slope failures or rockfalls observed along several cut slopes).
